EARTHQUAKE REPORT
TO
COMMITTEE 9
SEISMIC DESIGN FOR RAILWAY STRUCTURES
AMERICAN RAILWAY ENGINEERING
AND
MAINTENANCE-OF-WAY ASSOCIATION

JANUARY 26, 2001 GUJARAT, INDIA EARTHQUAKE

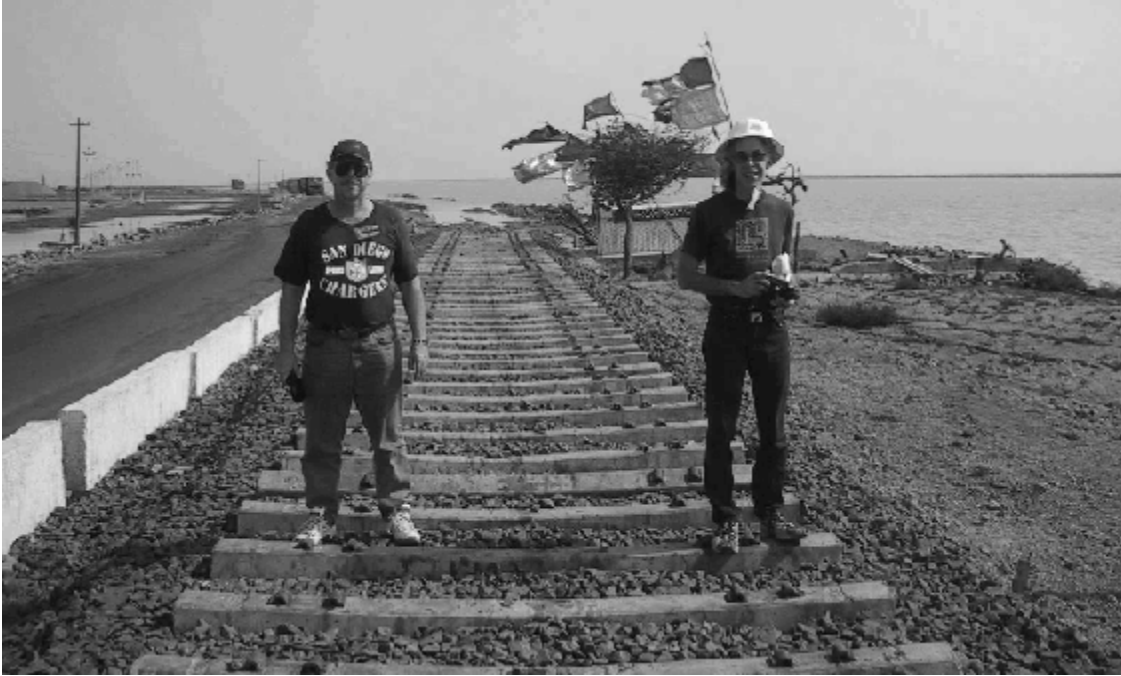
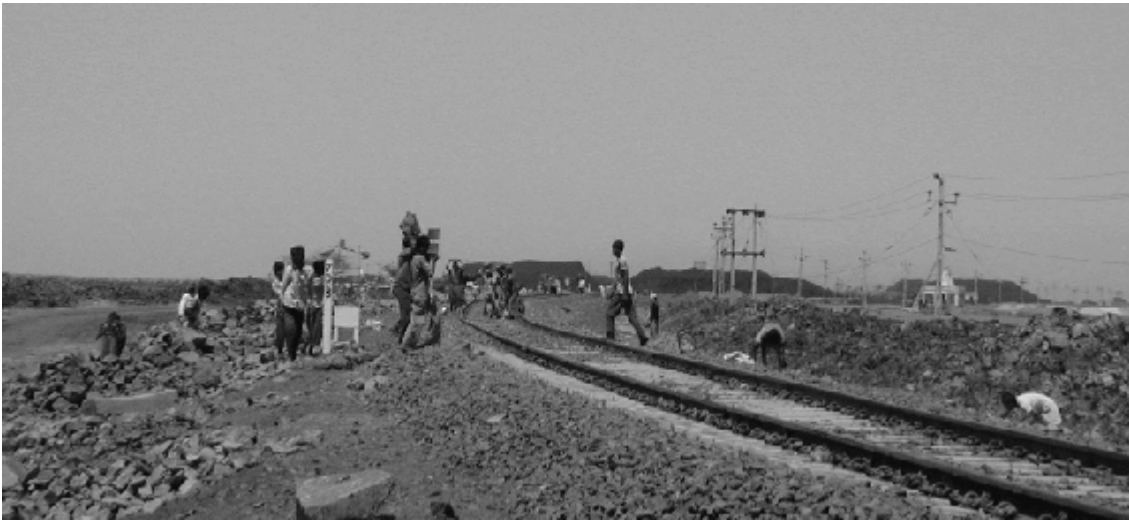
About 1 km of embankment and track shifted and settled into the Gulf of Kachchh near Navlakhi as a result of liquefaction and lateral spreading as shown in Figure 2. This track segment was replaced on a new alignment. The line was returned to service on March 31. Additional roadbed damage and track displacement occurred at a number of locations from slides and cracking due to lateral spreading. These locations were primarily northeast of Gandhidam, in an 18 km stretch around Bhachau. Settlement at bridge ends occurred as far east as the vicinity of Maliya Miyana. Ballast was displaced due to shaking at locations over a wide area. Examples of this damage are shown in Figures 3 through 5.

(a) Original alignment about March 1, 2001
(ASCE – TCLEE Earthquake Investigation Committee photo)

(b) New alignment on April 12, 2001

Figure 2. Submerged track near Navlakhi.

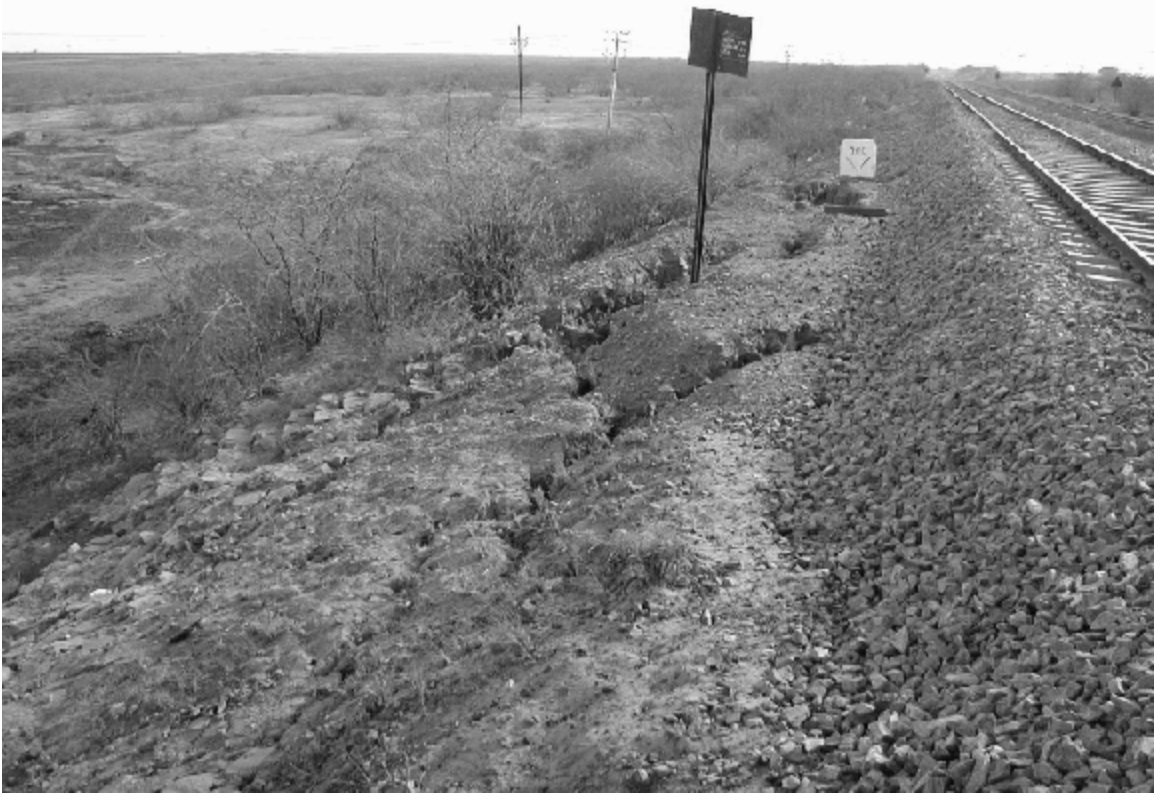
Figure 3. Cracks in embankment due to lateral spreading.

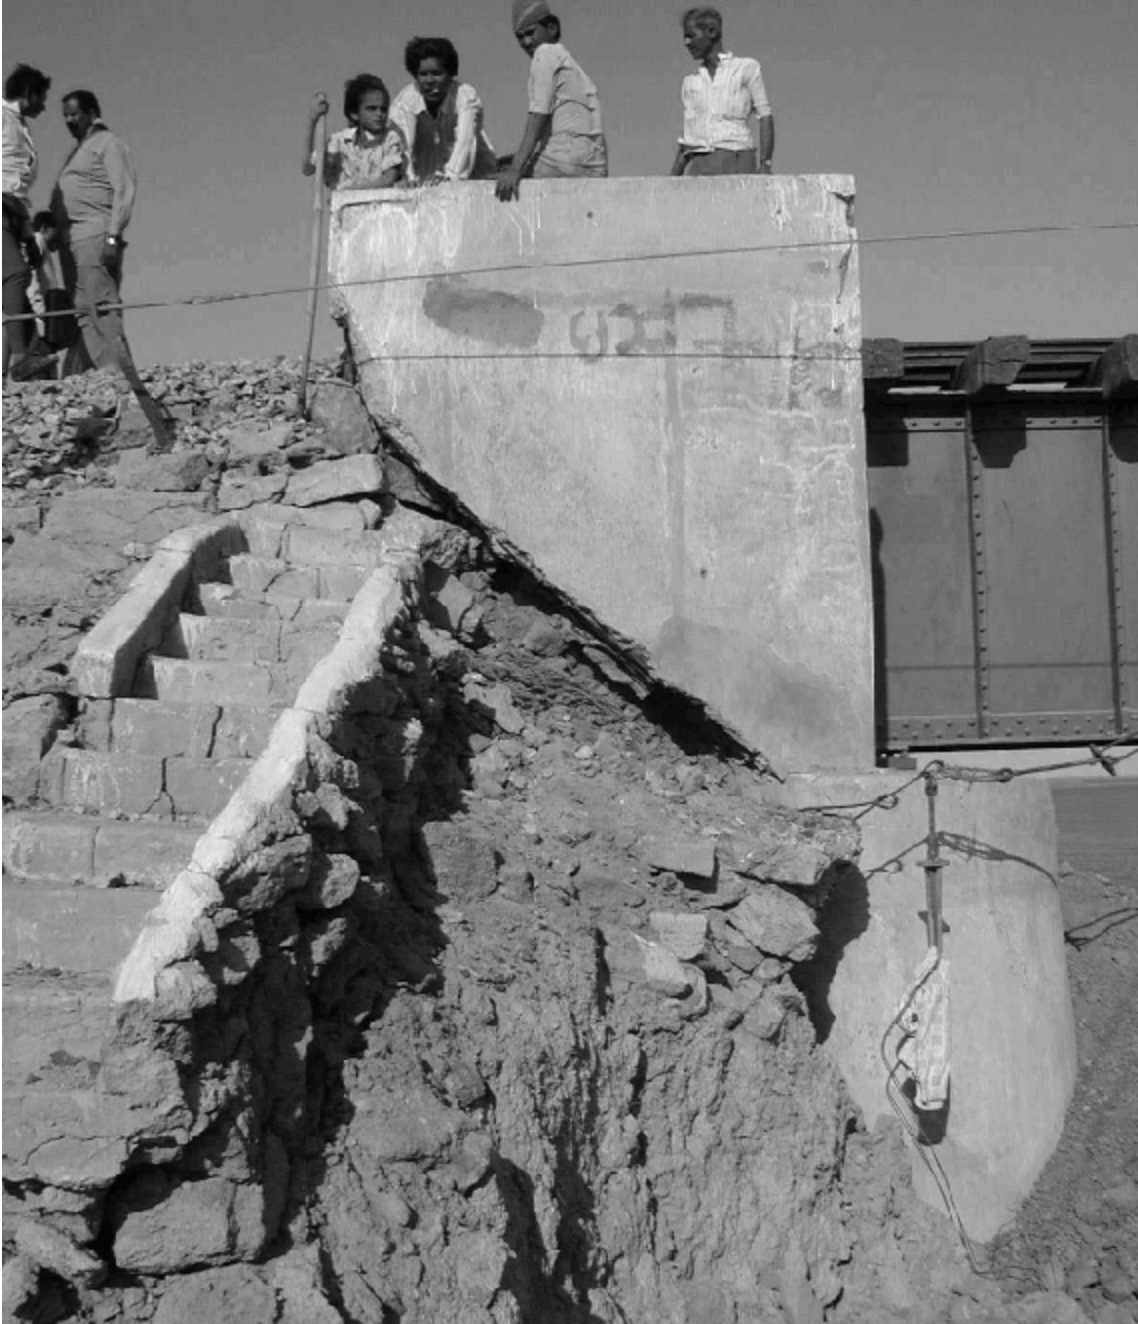
Figure 4. Settlement at Bridge No. 279

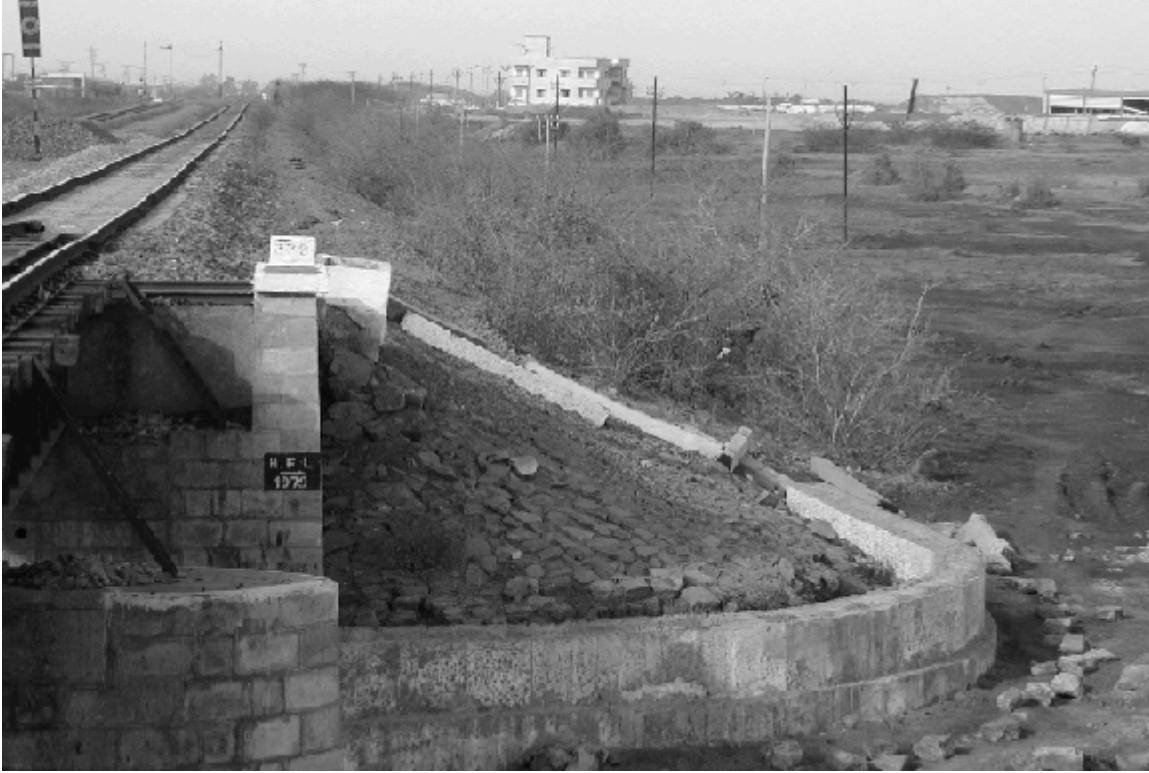
Figure 5. Settlement at Bridge No. 161

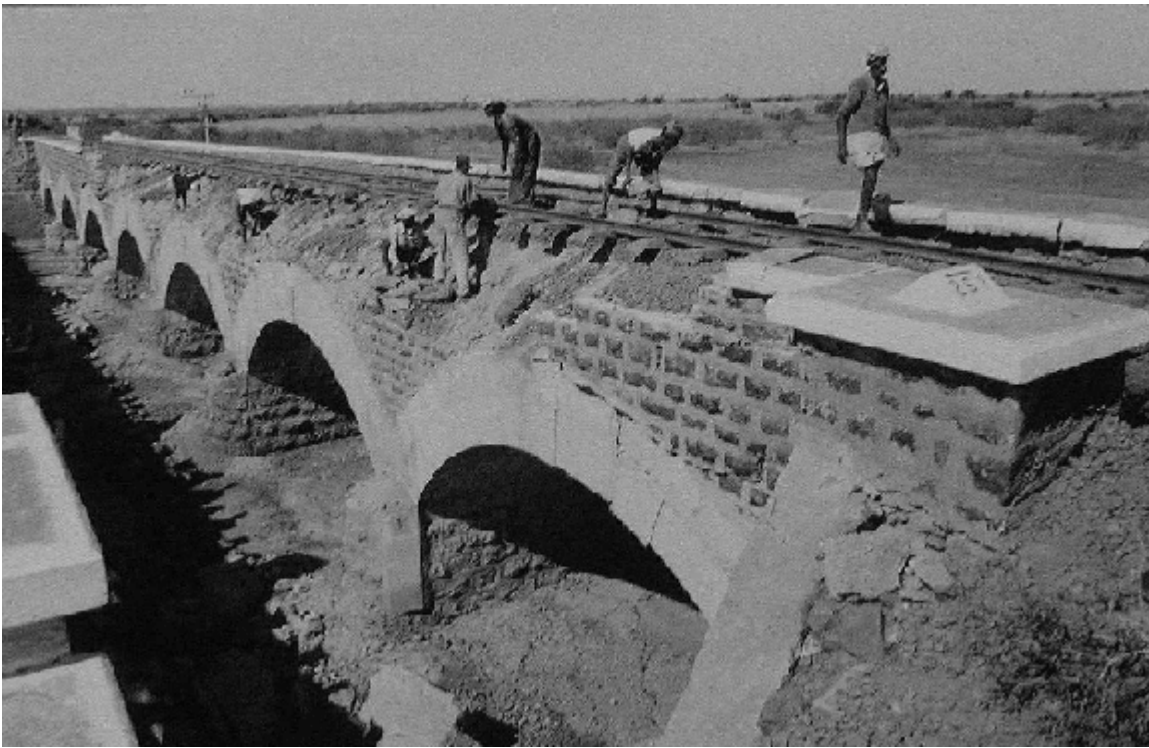
Bridges were damaged on 135 km of broad gage line between Bridge 161 across the Little Rann of Kachchh and Bhuj and 50 km of meter gage line between Samakhiyali and Gandhidham, which contained about 240 bridges and culverts, including 22 major bridges with spans greater than 12.2 meters or total length greater than 18.3 meters. A total of 12 bridges sustained significant damage. Six of 24 arch bridges, 5 of 75 girder bridges and one of 41 reinforced concrete slab bridges are included in this group. Arch bridge damage included failures caused by outward earth pressure against parapets and spandrel walls, cracking in mortar joints of arch rings and displacement of stones in arch rings due to outward movement of abutments. Girder bridge damage included movement of girders relative to piers and/or pier displacement resulting in unacceptable track geometry and, in some cases bearing and/or anchor bolt damage. Cracking of horizontal mortar joints of stone substructure units occurred in both girder and concrete slab bridges. Other bridge damage included separation of wing walls from abutments and other damage to wing walls. One reinforced concrete box had wing wall damage. Examples of bridge damage are shown in Figure 6 which shows parapet failure and displacement of stone in arch ring and in Figures 7 and 9.

Figure 6. Failed parapet and displaced stone in arch ring at Bridge No. 261
(Western Railway photo)

Consideration should be given to structurally connecting the parapets and spandrel walls of filled-spandrel arch bridges. Retrofitting existing bridges appears practical.

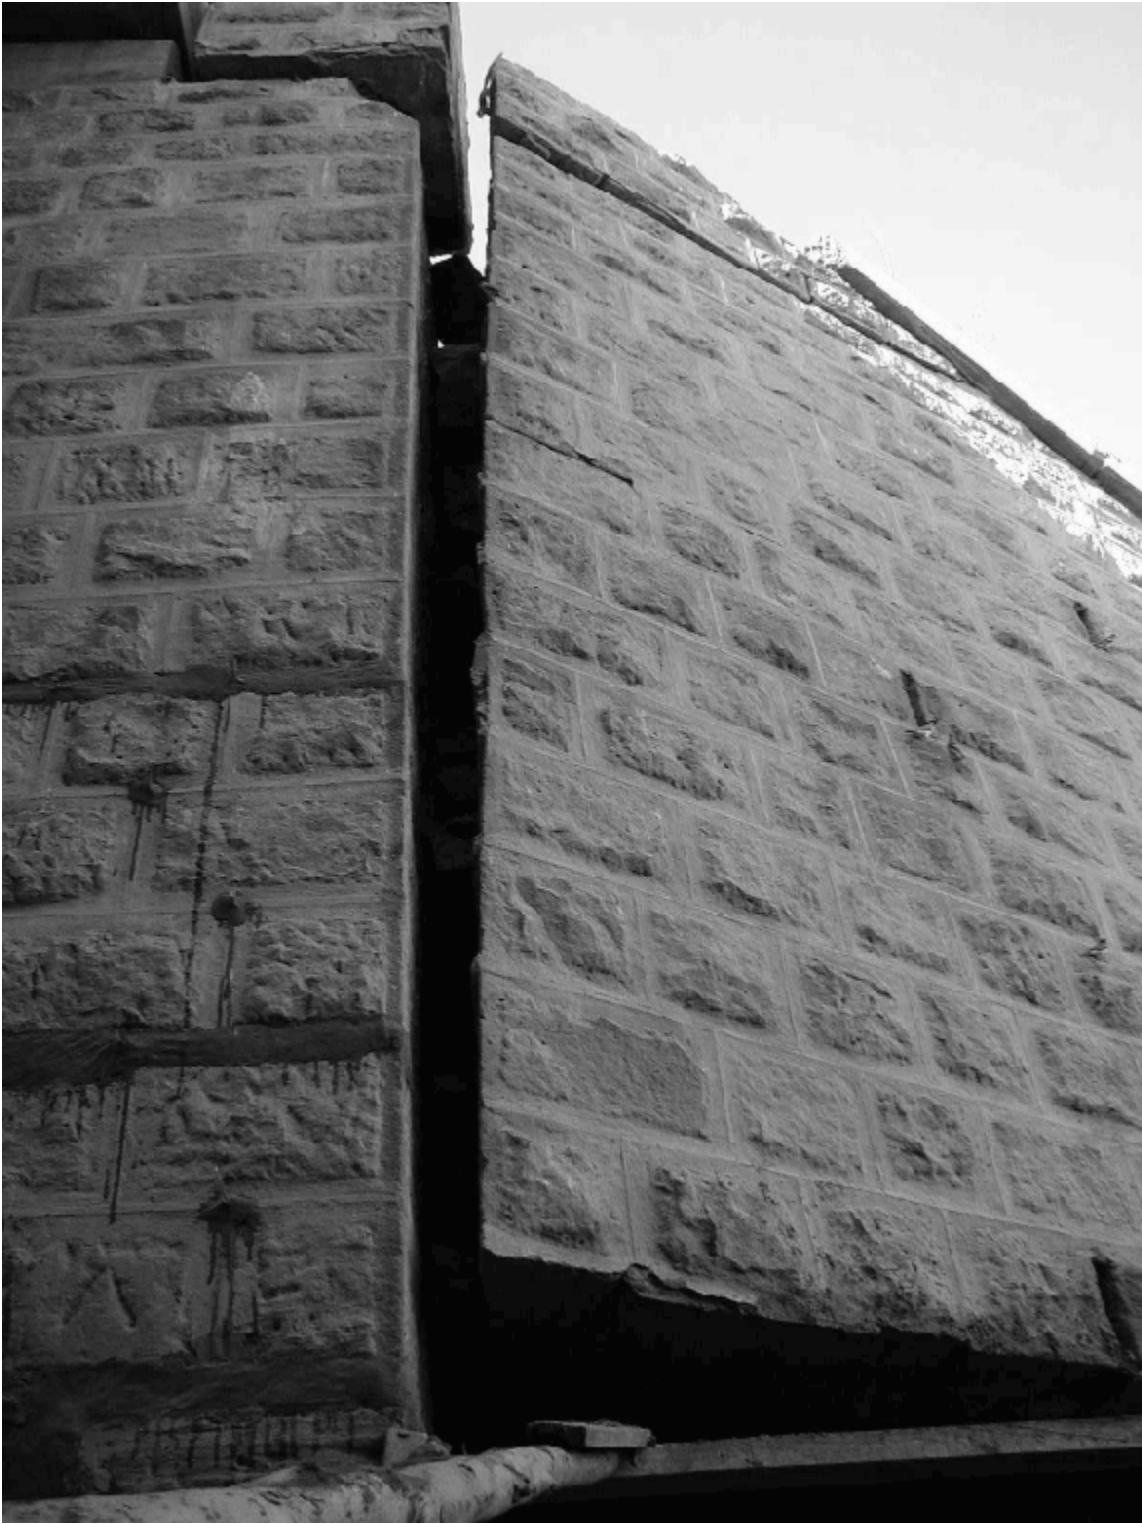
Figure 7. Wing wall separation at Bridge No. 271

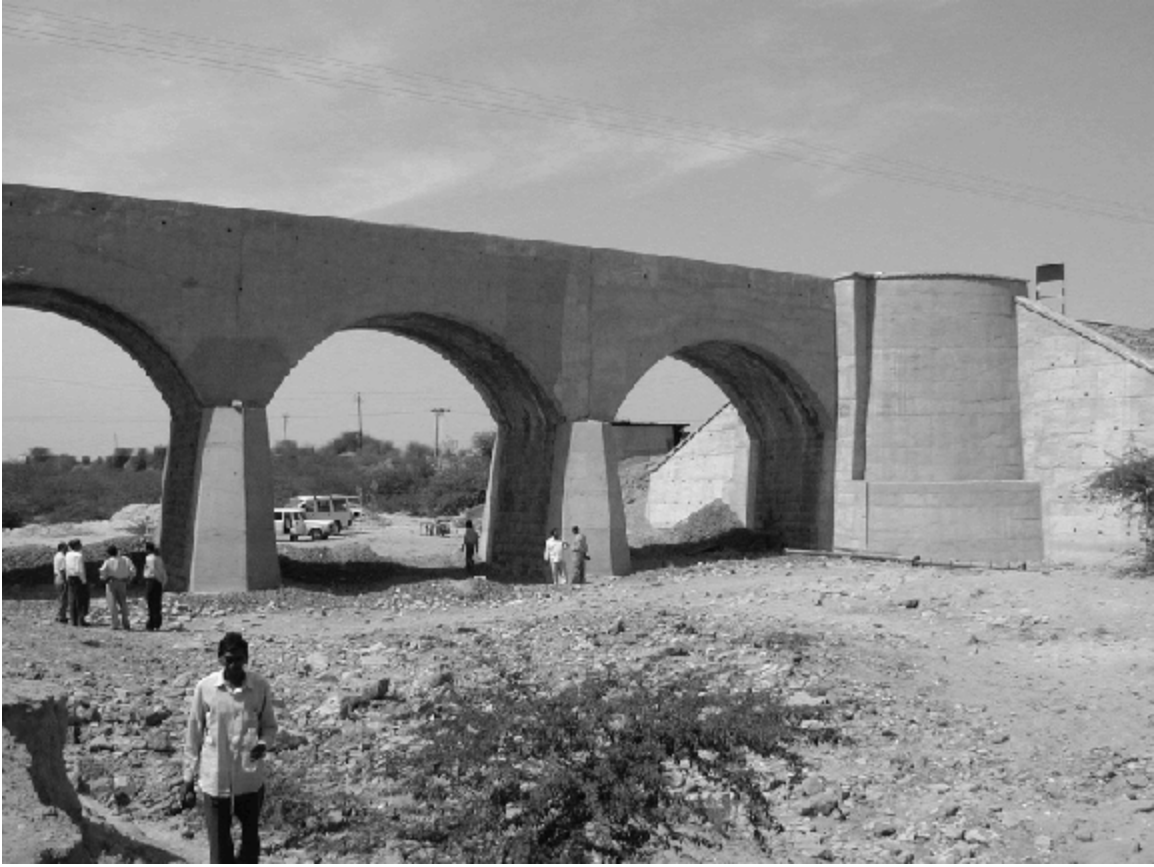
Figure 8. Bridge No. 48 converted from meter gage to broad gage by adding concrete on both sides of stone arches

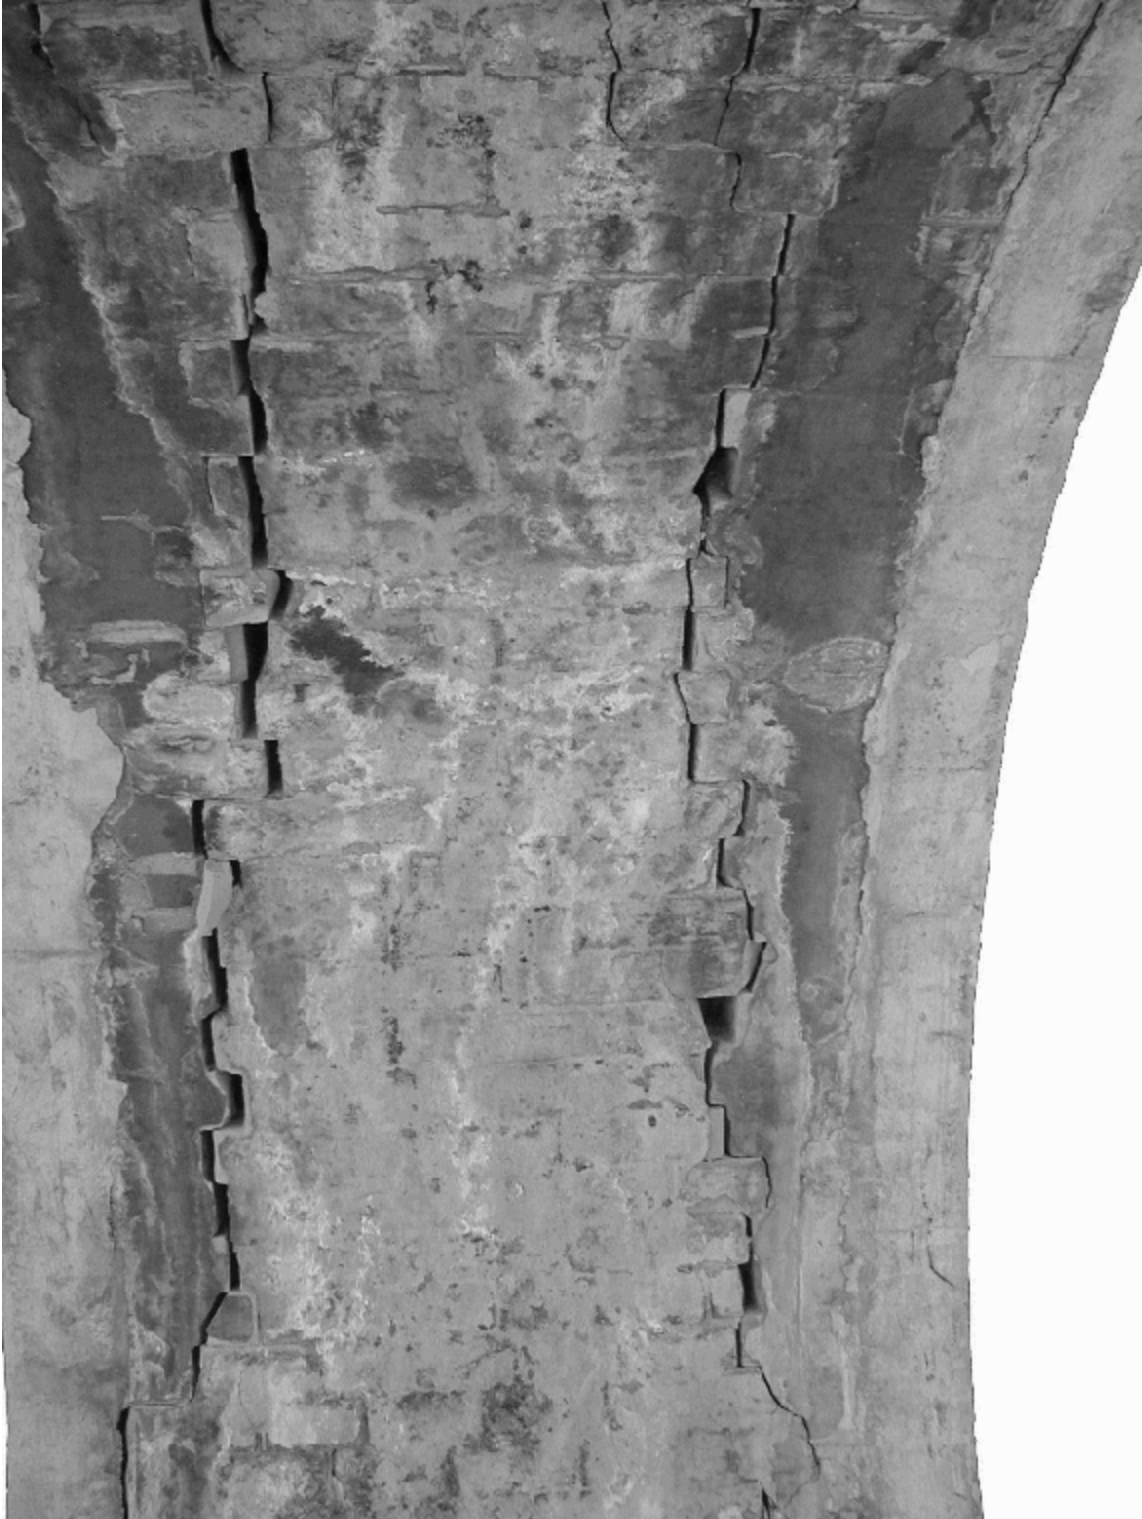
Figure 9. Separation along longitudinal joints in arch at Bridge No. 48

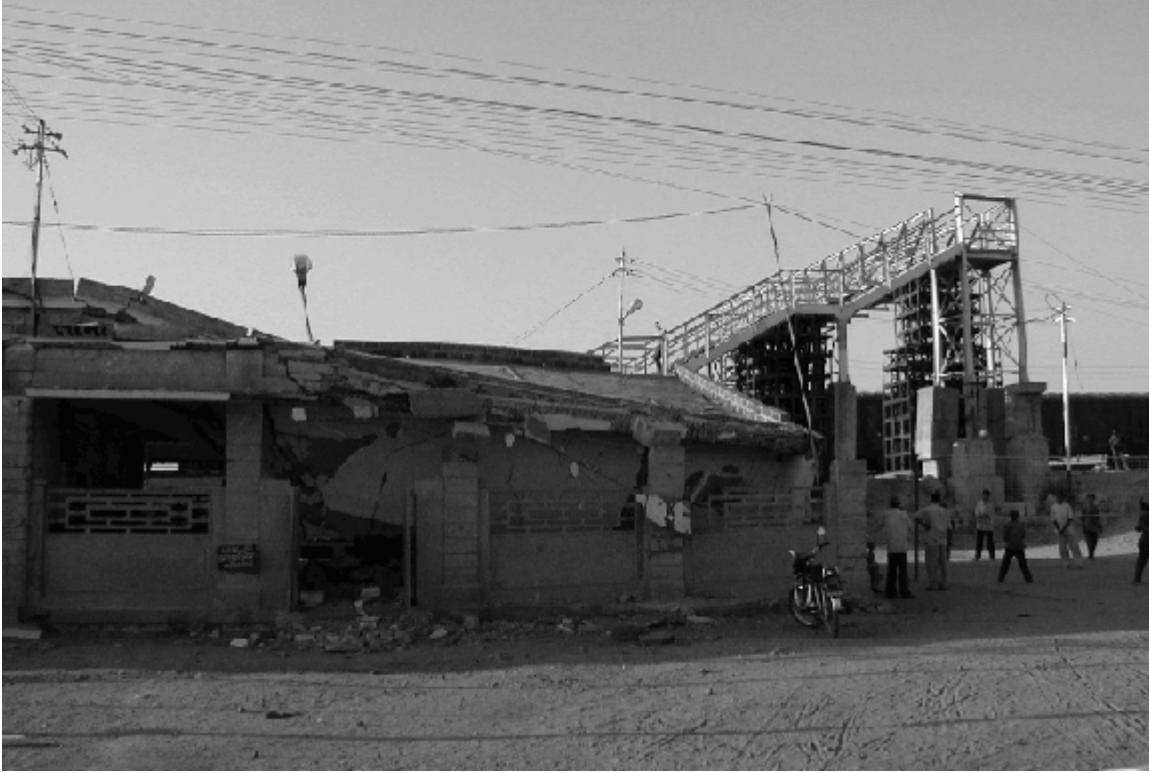
Figure 15. Samakhiyali station and foot bridge supported on cribbing

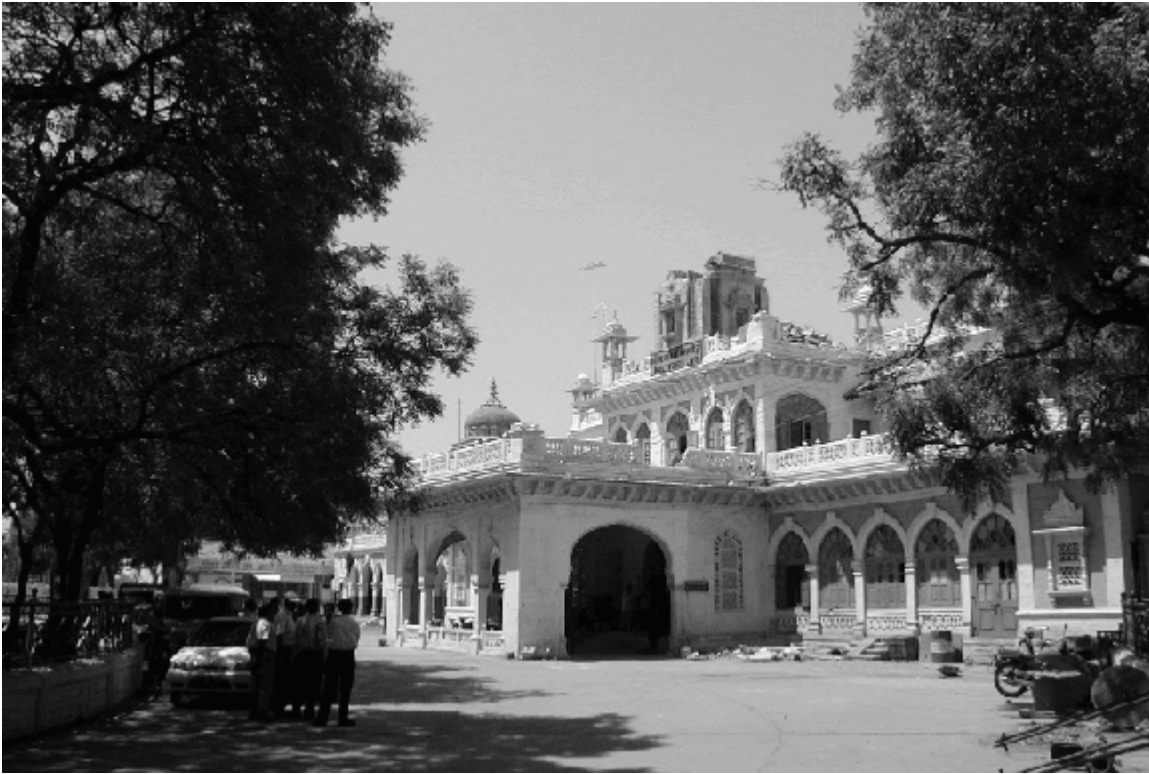
Damaged railway owned buildings numbered in the thousands with about one third damaged beyond repair. To keep this number in perspective, it should be noted that it includes housing units for a large percentage of railway employees, schools, hospitals and other facilities no longer typically owned by railroads in North America. It also includes a large number of minor structures, such as interlocking towers and cabins at road crossings with gates, which are all operated by employees at the crossings. Most stations between Samakhiali and Bhuj were damaged beyond repair. The station at Samakhiali is shown in Figure 15 together with a foot bridge over the tracks which had to be supported on falsework due to shear failures in the supporting concrete piers. Stations were also damaged over a much wider area. The station at Morbi is shown in Figure 16.

Figure 16. Morbi station after collapse of tower
