EARTHQUAKE REPORT
TO
COMMITTEE 9
SEISMIC DESIGN FOR RAILWAY STRUCTURES
AMERICAN RAILWAY ENGINEERING
AND
MAINTENANCE-OF-WAY ASSOCIATION

FEBRUARY 28, 2001 NISQUALLY, WA EARTHQUAKE

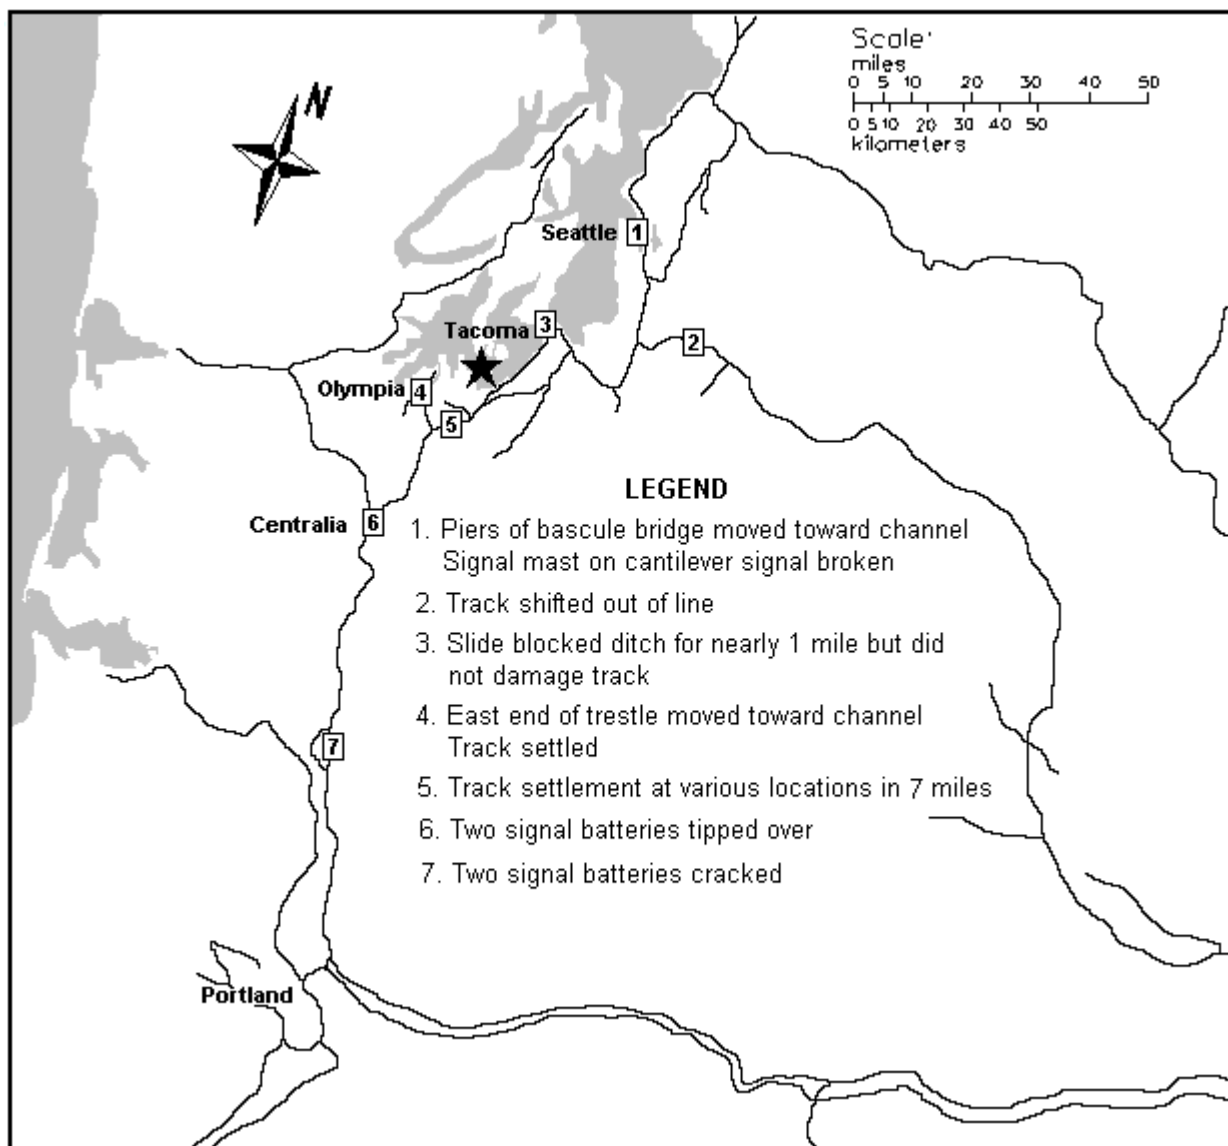
Locations of damage to railroad facilities, other than buildings, are shown in Figure 1. Location of epicenter is indicated by a star.

Figure 1. Damage to railroad facilities other than buildings.

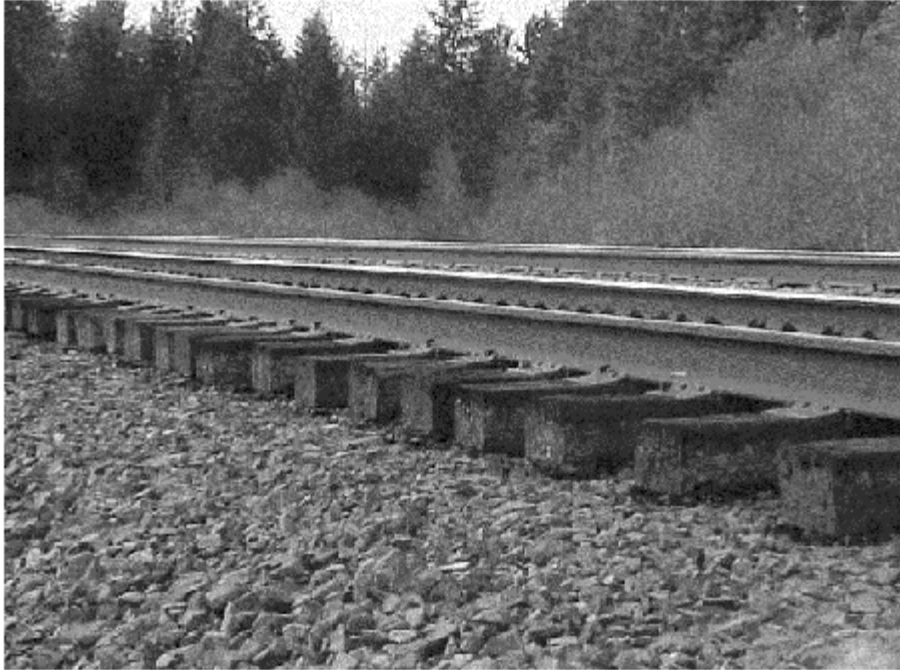
At various locations between MP 30 and MP 37 on Seattle Subdivision, track settled at bridge ends, embankment settled and shifted and ballast was lost under ties. Typical damage in this area is shown in Figures 2 to 4. Track movements were, in general, less than 1 foot. Most damage was to Track 2. Embankment for Track 2 was constructed against embankment for Track 1 after Track 1 had been in service for a number of years. Tracks are at 13 ft. centers. Location is about 10 miles from epicenter.

Figure 2. Settlement under track at MP 30.9.

Restoration of track to normal standards following an earthquake may require sizeable quantities of ballast.

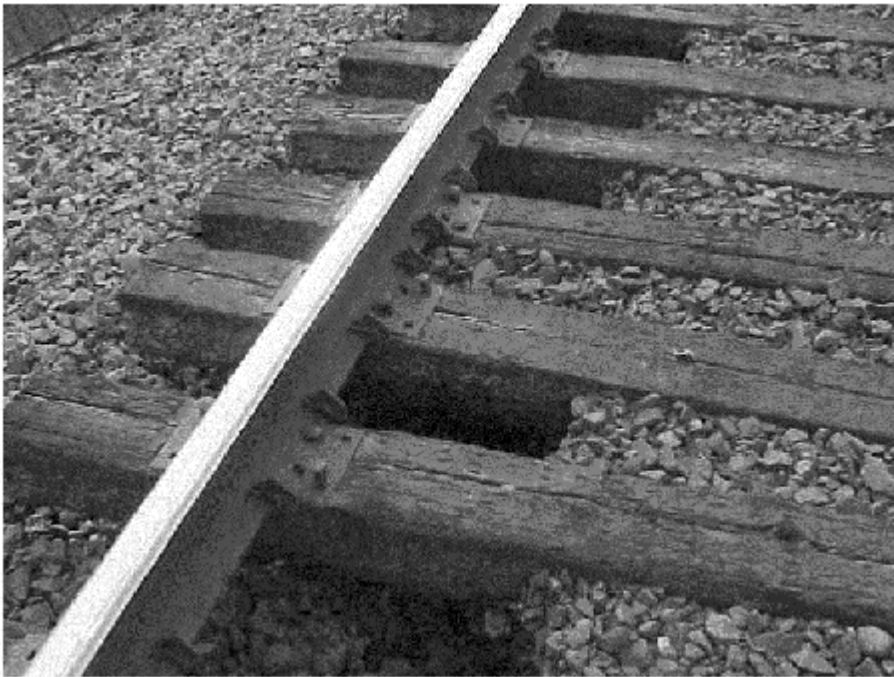
Figure 3. Ballast loss over pipe culvert at MP 30.92.

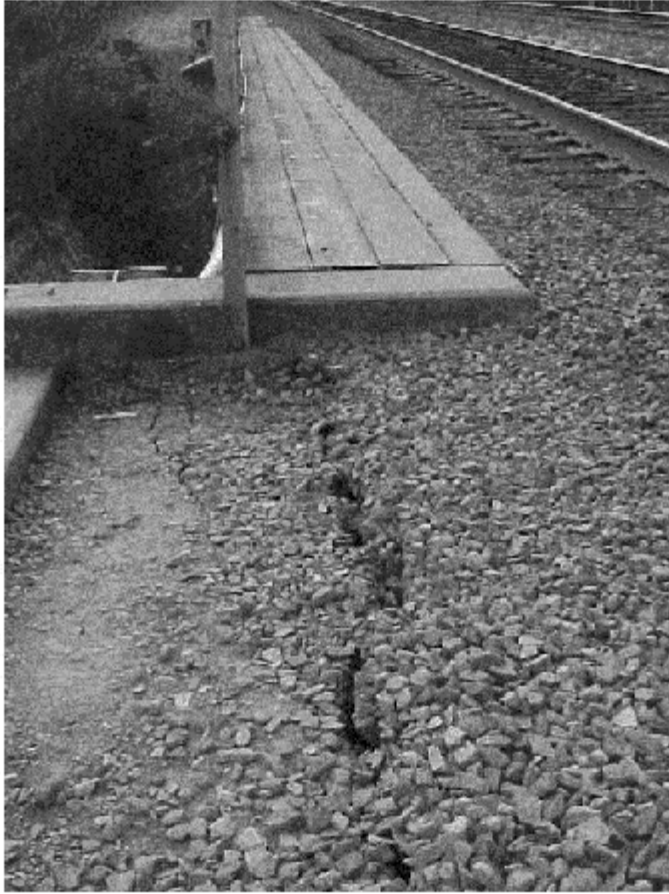
Figure 4. Settlement at bridge end at MP 31.6.

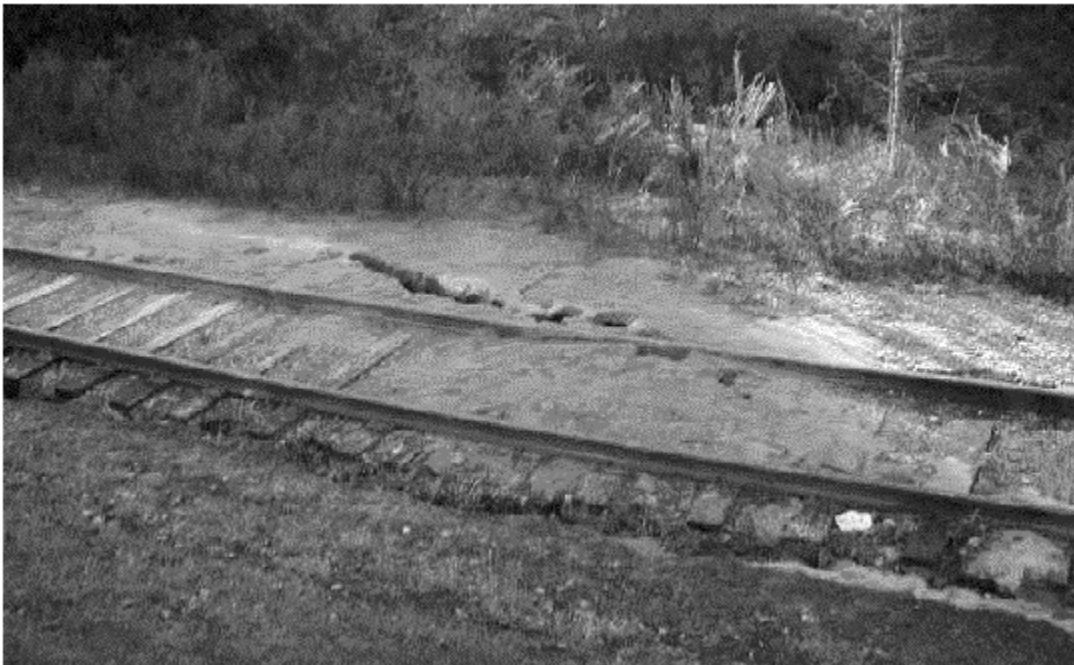
There was considerable liquefaction affecting track with settlement and sand ejection, as shown in Figure 5, near Capitol Lake in Olympia. Maximum settlement was in an area where trestle approaches to a bridge had been filled. Track settled between 1 and 2 feet until it rested on caps of trestle which were left in place when stringers were removed. Settlement at east end of bridge is shown in Figure 6. Lateral spreading was observed in the area. Location is about 10 miles from epicenter.

Figure 5. Liquefaction near Capitol Lake in Olympia.

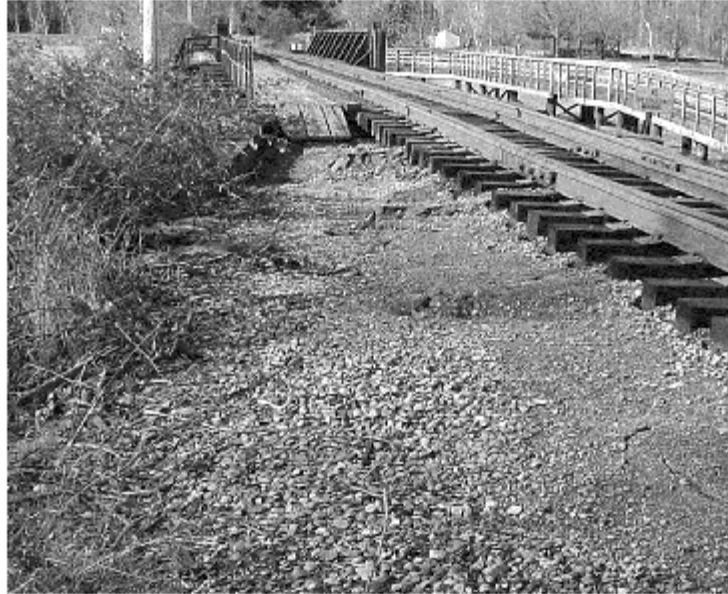
Figure 6. Settlement at bridge end at Capitol Lake.

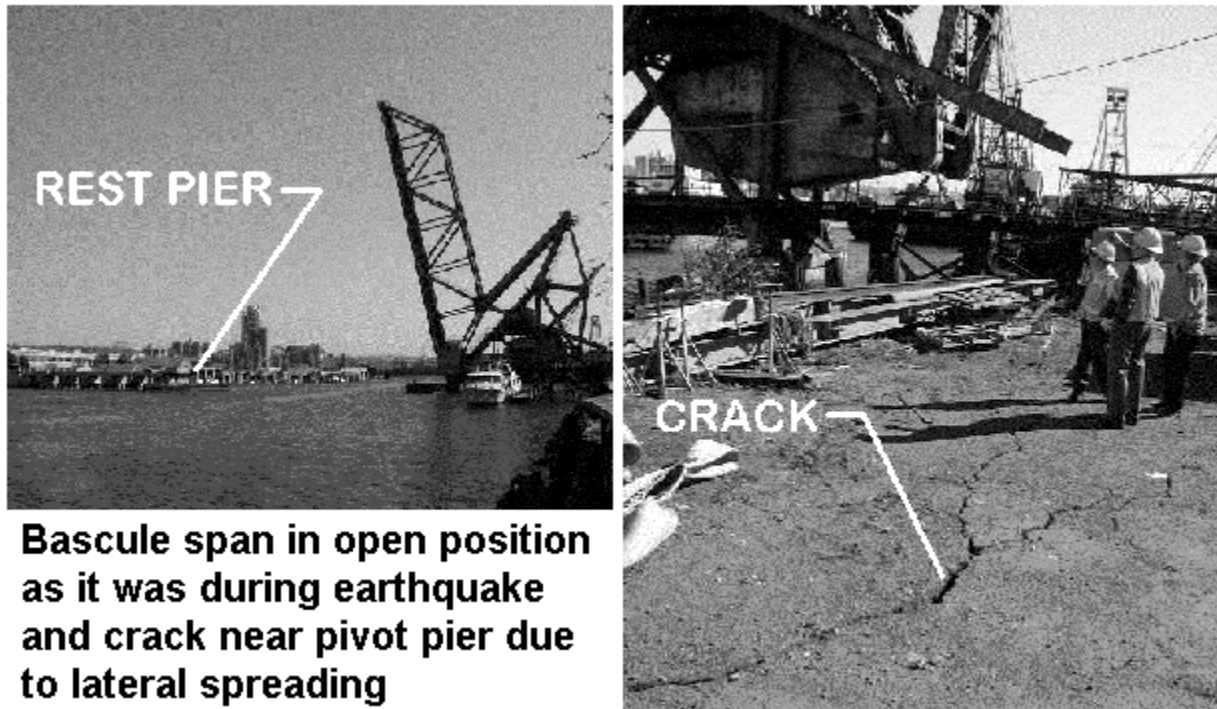
A bascule bridge in Seattle, about 30 miles from the epicenter, was open at the time of the earthquake. Following the earthquake, it was impossible to close the bridge as the pivot pier and rest pier had moved together about 0.5 ft. Two spans in the east approach moved together about 0.3 ft. Additional movement amounting to several inches occurred during the following week. The bridge, in the open position, and cracks from lateral spreading due to liquefaction are shown in Figure 7.

Figure 7. Bascule span in open position and cracks in ground behind pivot pier.

Moveable bridges should either have provisions to allow closing after movement of supporting piers or be normally kept in the closed position.
