EARTHQUAKE REPORT
TO
COMMITTEE 9
SEISMIC DESIGN FOR RAILWAY STRUCTURES
AMERICAN RAILWAY ENGINEERING
AND
MAINTENANCE-OF-WAY ASSOCIATION

JUNE 23, 2001 ATICO, PERU EARTHQUAKE

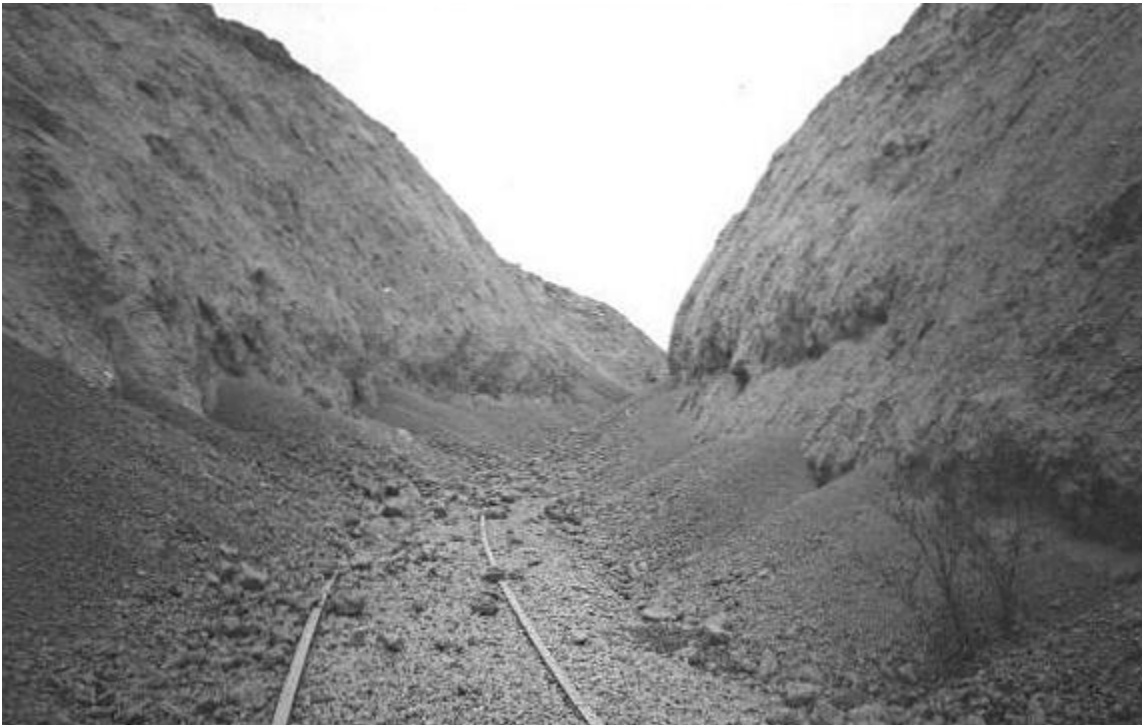
The most severe damage involved material sliding or falling onto the track, as shown in Figures 2 to 4, or embankment failures, as shown in Figures 5 and 6. In some cuts, track was buried under as much as 5 meters of material. There were cases where ballast was displaced without obvious subgrade problems as shown in Figure 7. There were also cases where failures did not occur but longitudinal cracks indicating a potential slide did, as shown in Figure 8. Partially developed slides above the track, as shown in Figure 9, represent a potential future maintenance problem.

Figure 2. Cut at Matarani-Arequipa KM 17 (*PeruRail photo*)

Where not prohibitively expensive, several measures could reduce the risk of service interruptions and/or reduce their extent and duration. Cuts could be widened to allow accumulation of debris at the bottom of slopes without fouling the track. In cases where rock has been fractured by excessive blasting, fractured rock could be scaled from the sides of cuts. In naturally fractured or jointed formations, grouting of cracks and/or rock bolting to improve stability could be considered. Some of the methods used to prevent other slides in embankments would be beneficial.

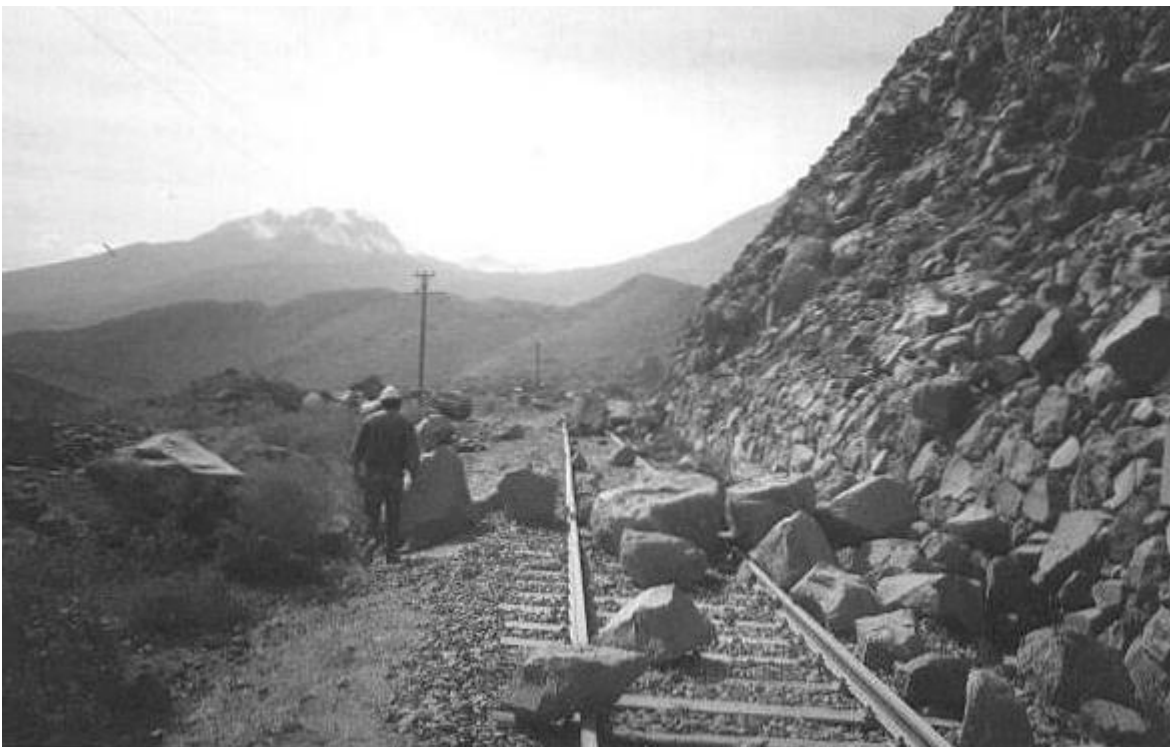
Figure 3. Rock-fall at Arequipa-Puno KM 35 (*PeruRail photo*)

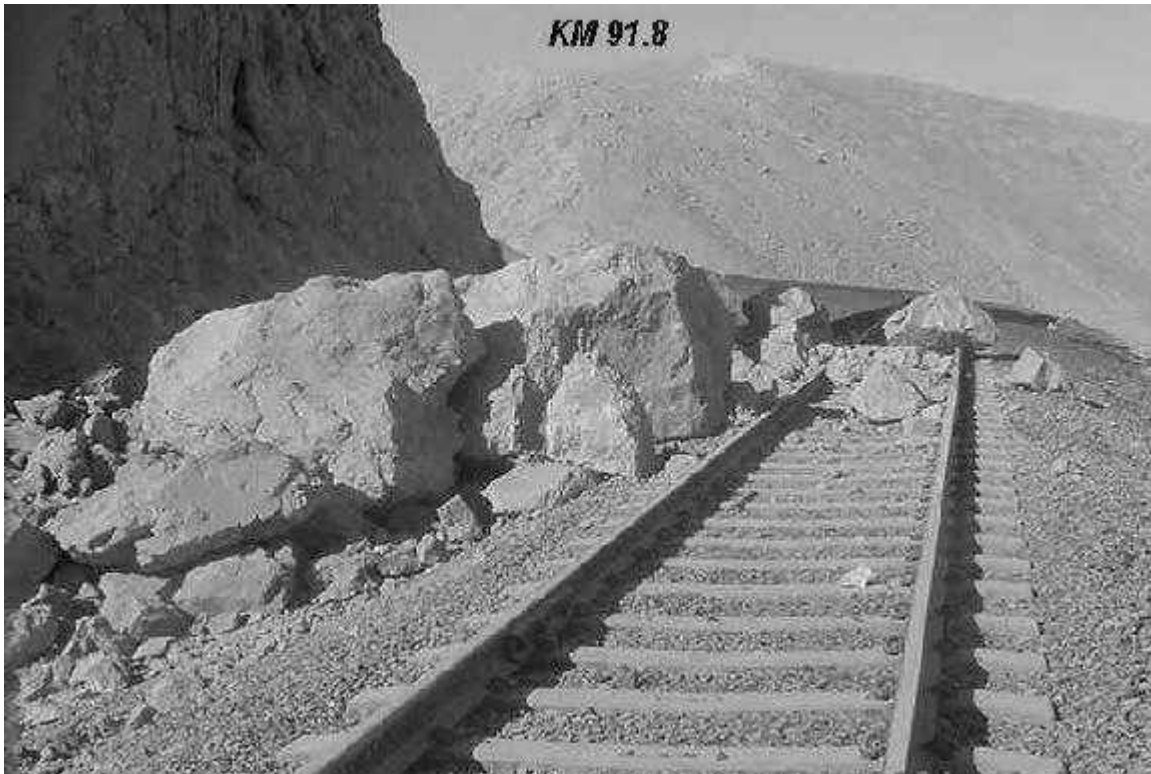
Figure 4. Rock-fall at SPCC KM 90 (*Southern Peru Copper Corp. photo*)

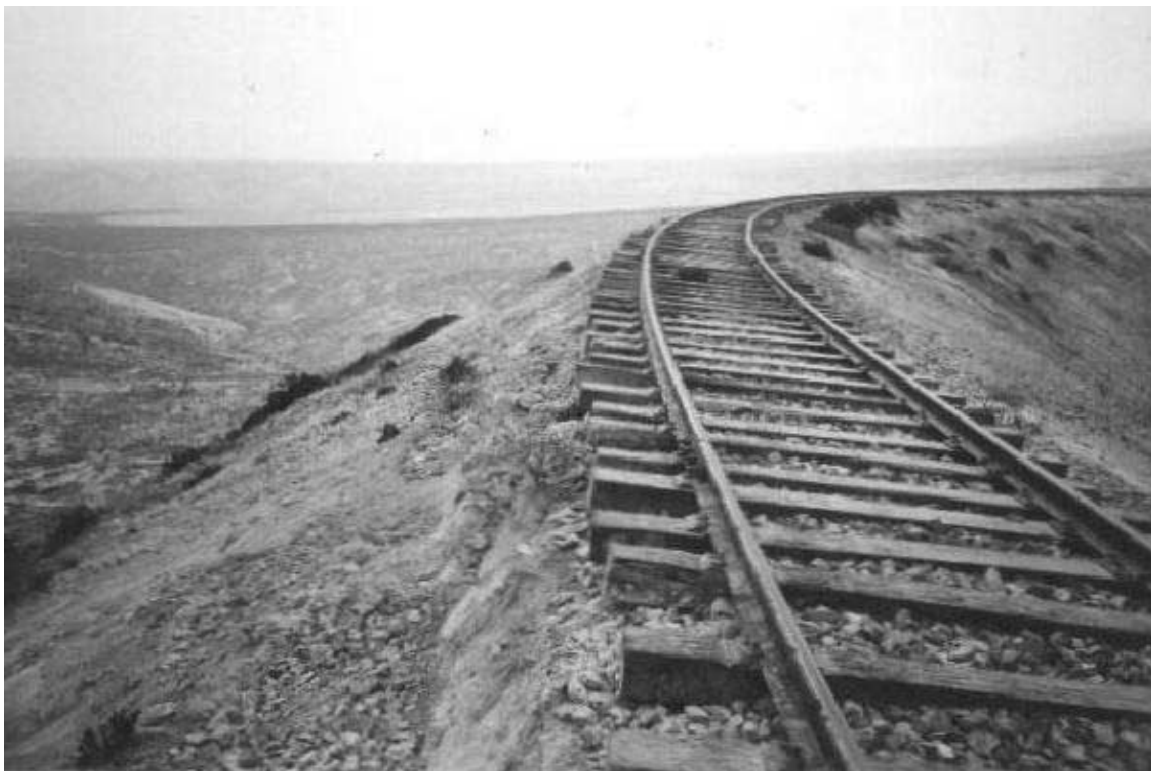
Many embankments with problems were composed of material that appeared to have little cohesion and uniform gradation. Because of the lack of a shallow water table, liquefaction does not appear to have been a factor in any of the failures. A significant percentage of embankment failures involved slides, or longitudinal cracking indicating a potential slide, as shown in Figure 8, in the region between the ends of ties and the shoulder. It is possible that, over time, traffic loading, combined with a limited amount of moisture penetrating the ballast, increased consolidation and cohesion in the fill under the ties. Such increased cohesion would increase the relative probability of potential failure surfaces beyond the ends of ties. Although the Southern Peru Copper Corporation Railroad was doubtless constructed using modern methods and equipment, the lack of available water would have resulted in compaction at a moisture content far below optimum. At other locations, slides involved the entire width of the fill. Figure 10 shows the top of a minor slide extending under the track. The region to the left has been displaced downward in relation to the track and the region to the right.

Figure 5. Slide at Matarani-Arequipa KM 14 (*PeruRail photo*)

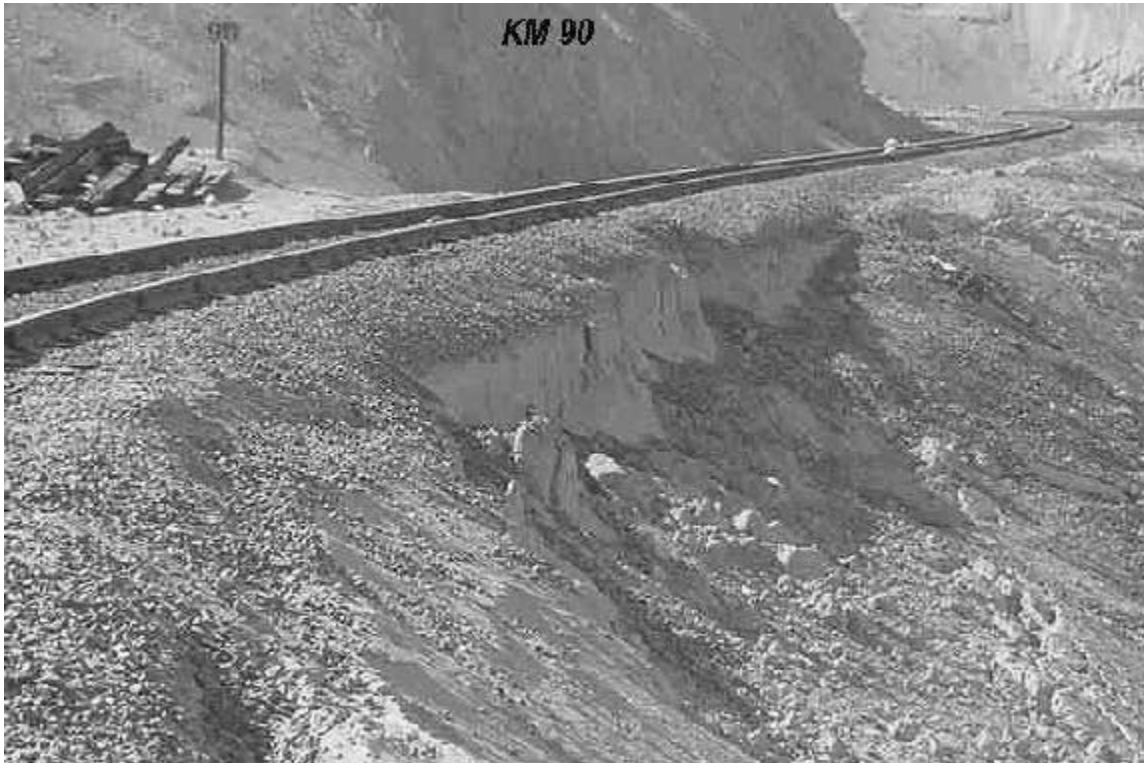
Figure 6. Slide at SPCC KM 90 (Southern Peru Copper Corp. photo)

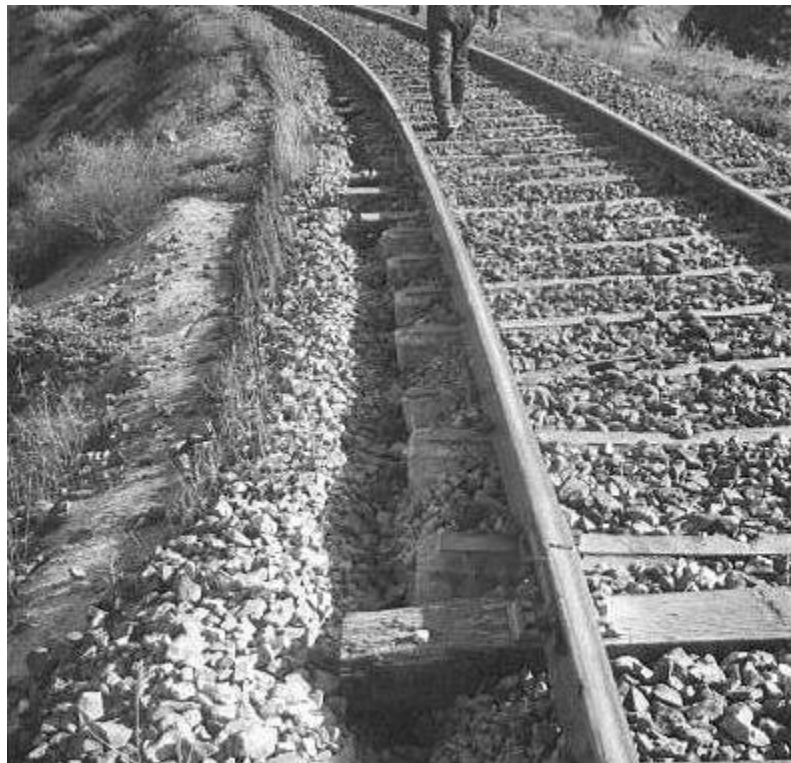
Figure 7. Displaced ballast at Arequipa-Puno KM 49 (PeruRail photo)

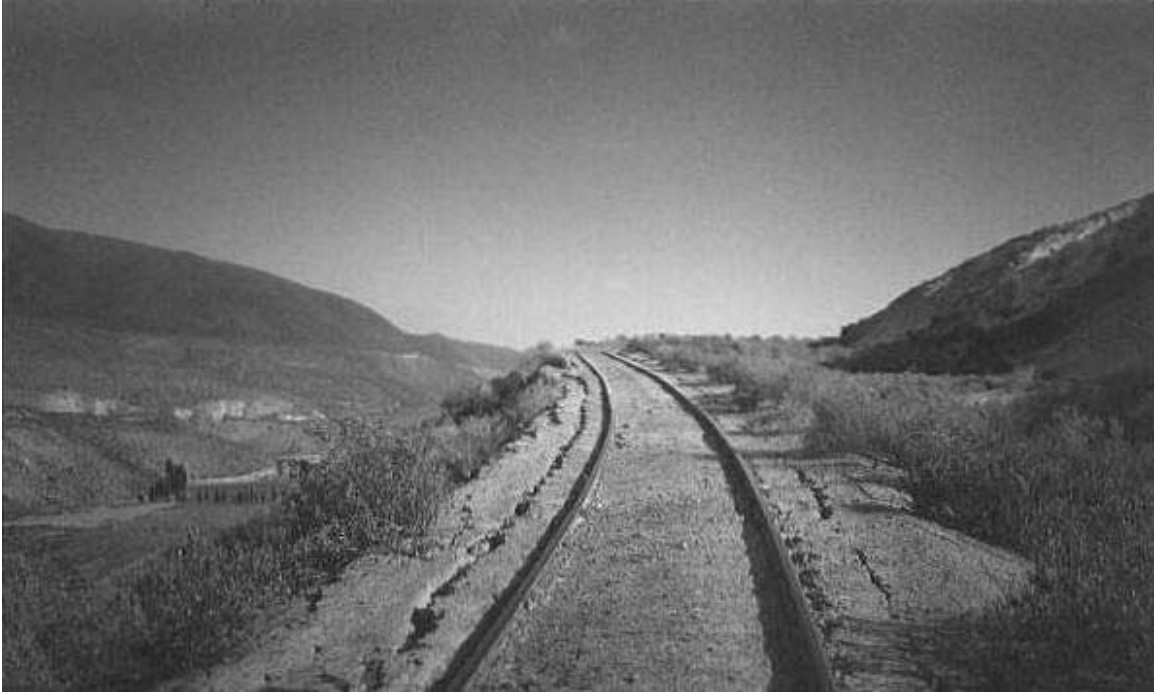
Figure 8. Embankment cracks at Arequipa-Puno KM 50 (*PeruRail photo*)

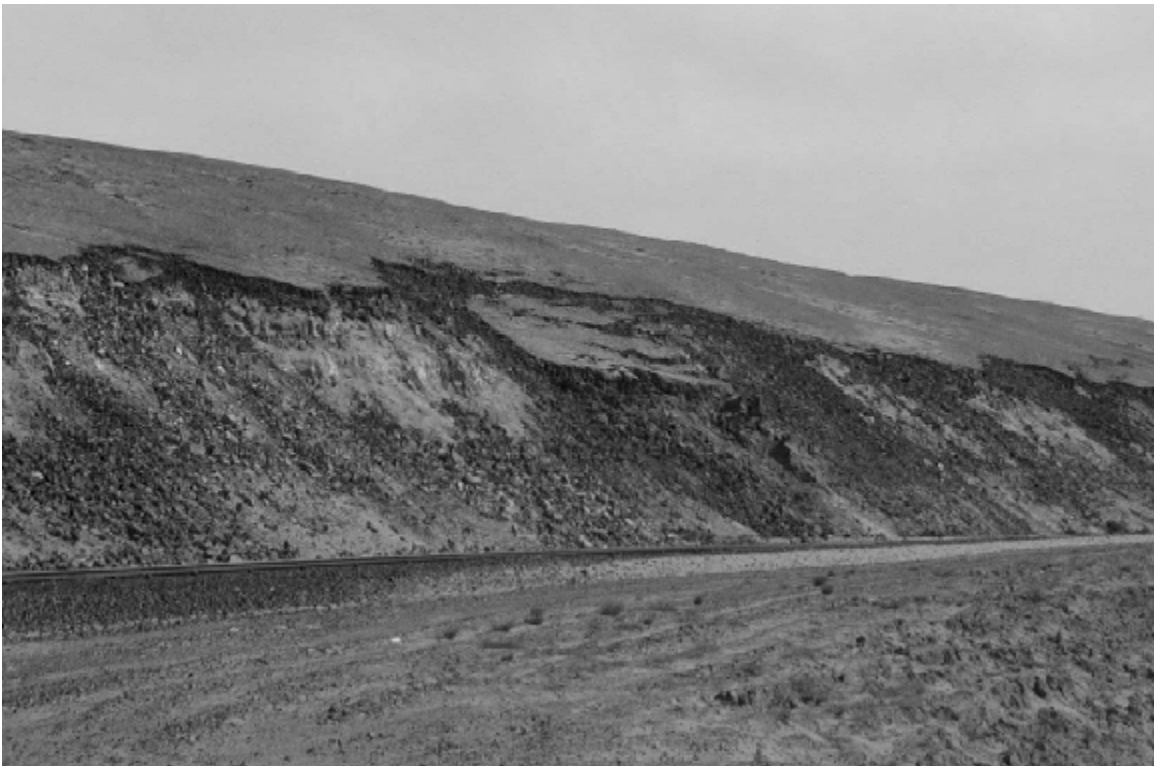
Figure 9. Slide above track near SPCC KM 40

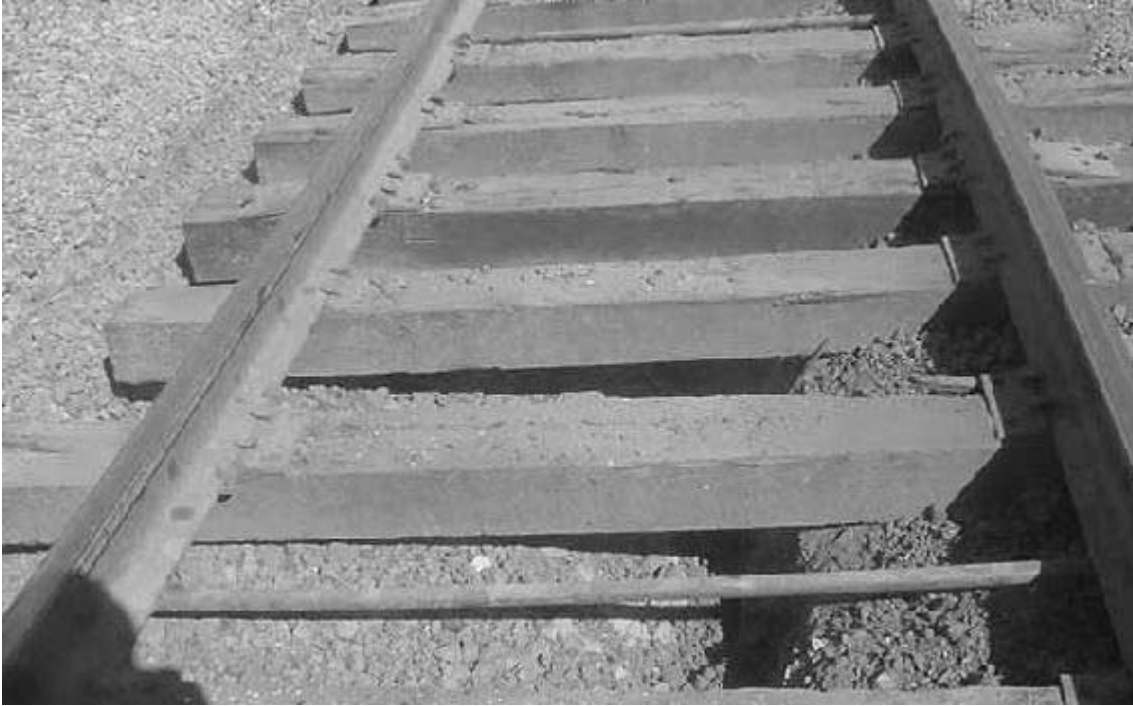
Figure 10. Slide at SPCC KM 87.6 (*Southern Peru Copper Corp. photo*)
