EARTHQUAKE REPORT
TO
COMMITTEE 9
SEISMIC DESIGN FOR RAILWAY STRUCTURES
AMERICAN RAILWAY ENGINEERING
AND
MAINTENANCE-OF-WAY ASSOCIATION

JUNE 23, 2001 ATICO, PERU EARTHQUAKE

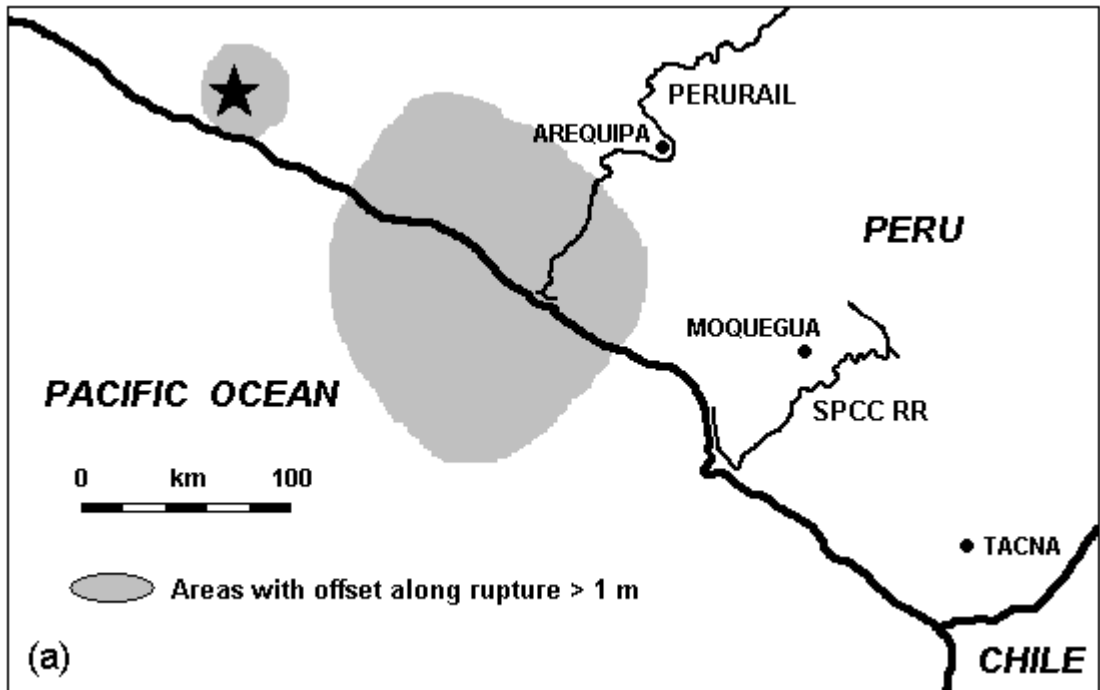
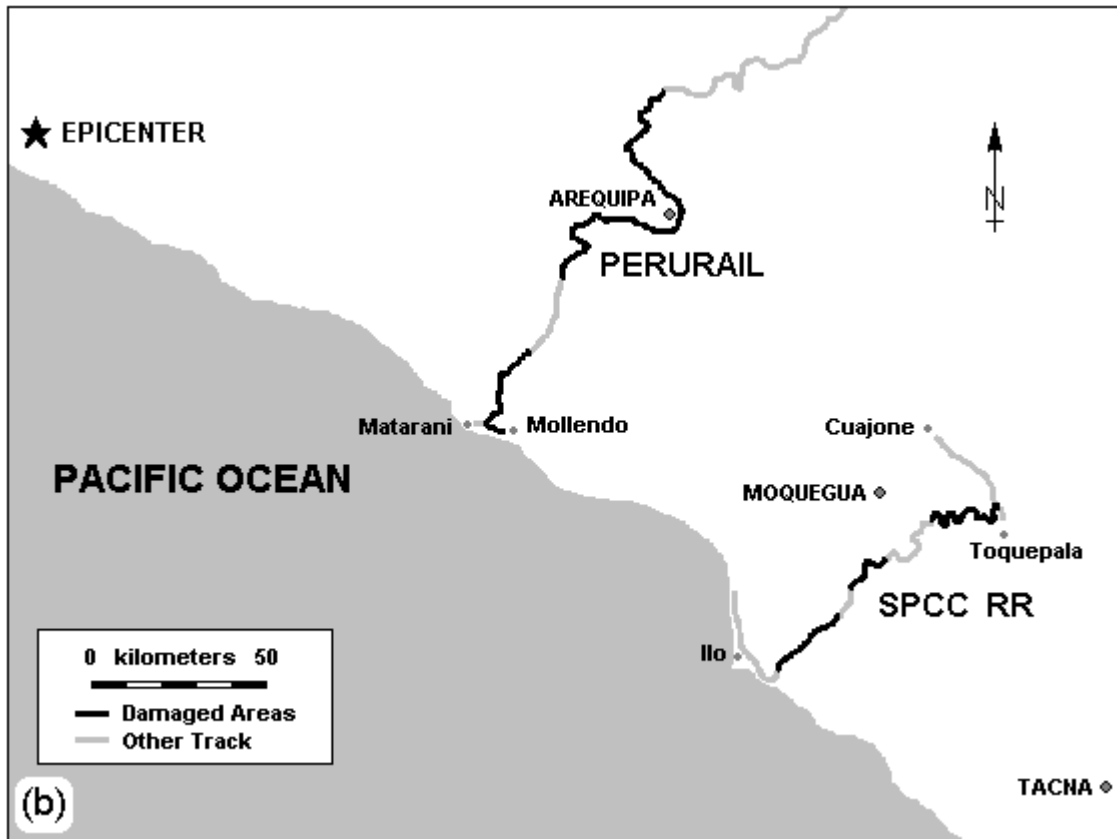
Figure 1. Atico, Peru earthquake and affected railroads

Both the Mollendo-Matarani-Arequipa-Puno line of PeruRail and the Southern Peru Copper Corporation (SPCC) railroad sustained extensive damage in the areas indicated in Figure 1b.
